Audi Q7 4L (2005 - 05/2015) - Repair of a Worn Propeller Shaft Center Support Mount without Removal of the Shaft - Option 1

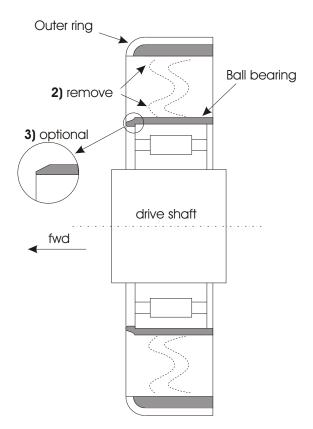
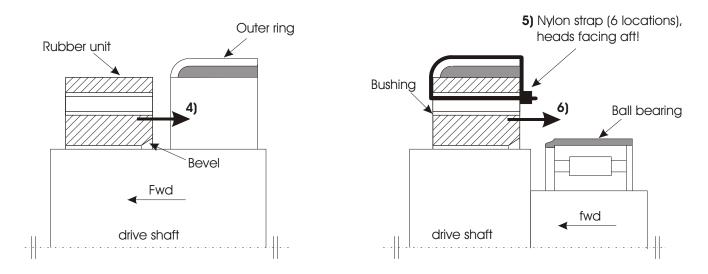
- Remove and keep stiffener bracket next to the center mount, 6 bolts M10. Compare with option 2 at page 2. Then loosen 2 bolts XZN M8 of center support mount. The outer ring is loose around the forward part of the shaft.

- Remove/cut off rubber remains from the outer ring and from the ball bearing. Keep rubber layer (1-2mm) on the ball bearing outer race and rubber inlay (3mm) on the outer ring to ensure the repair kit fits with correct tension.

- 3) **Optional**: A slight chamfer may be cut into the rubber at the forward side of the ball bearing.
- 4) Put the new rubber unit around the forward part of the drive shaft and position it into the outer ring. **Opening on top! Bevel facing aft!**

- 5) Install all 6 tie straps to attach the rubber unit to the outer ring. **The heads shall face aft (see figure).**
- 6) Move the whole assy over the bearing. Start on top. Silicone spray may help (before you start trimming the rubber layer on the roller bearing). Finally align the unit with the bearing.

7) Re-install stiffener bracket and center support mount on the car, 6 bolts M10, torque to 60Nm. 2 bolts XZN M8, 20Nm torque.
