## Cayenne 92A / Touareg 7P (BJ 05/2010-2017) - Repair of a Worn Rubber Bearing of the Propeller Shaft Center Support Mount without Removal of the Shaft

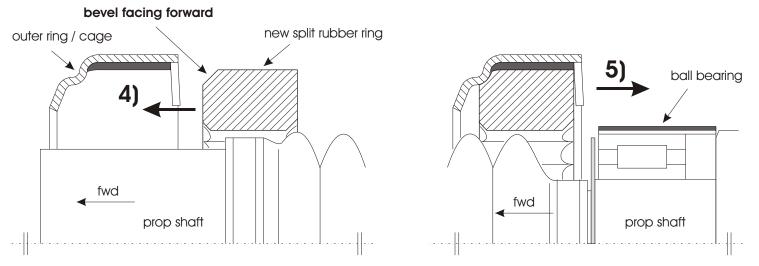
4) Insert the new split rubber ring into the cage. Opening on top! Bevel facing forward!

In front of the cuff: It starts with one end on top of the cage. Then the ring is put circumferentially behind the 4ea backup supports and aligned with the cage backside. If it does not slip over the cuff, check seating, rework of the cage to remove all remains of the lip may be required (see 2)

5) Move/pull the whole assy over the roller bearing. Align and re-attached preferably tension free (2 bolts M8, 20Nm torque). Finally re-install stiffener bracket (6 bolts M10, torque to 60Nm).
